Hampstead Heath: Viaduct Pond Management Plan

By Ben Bewsher

28/09/09

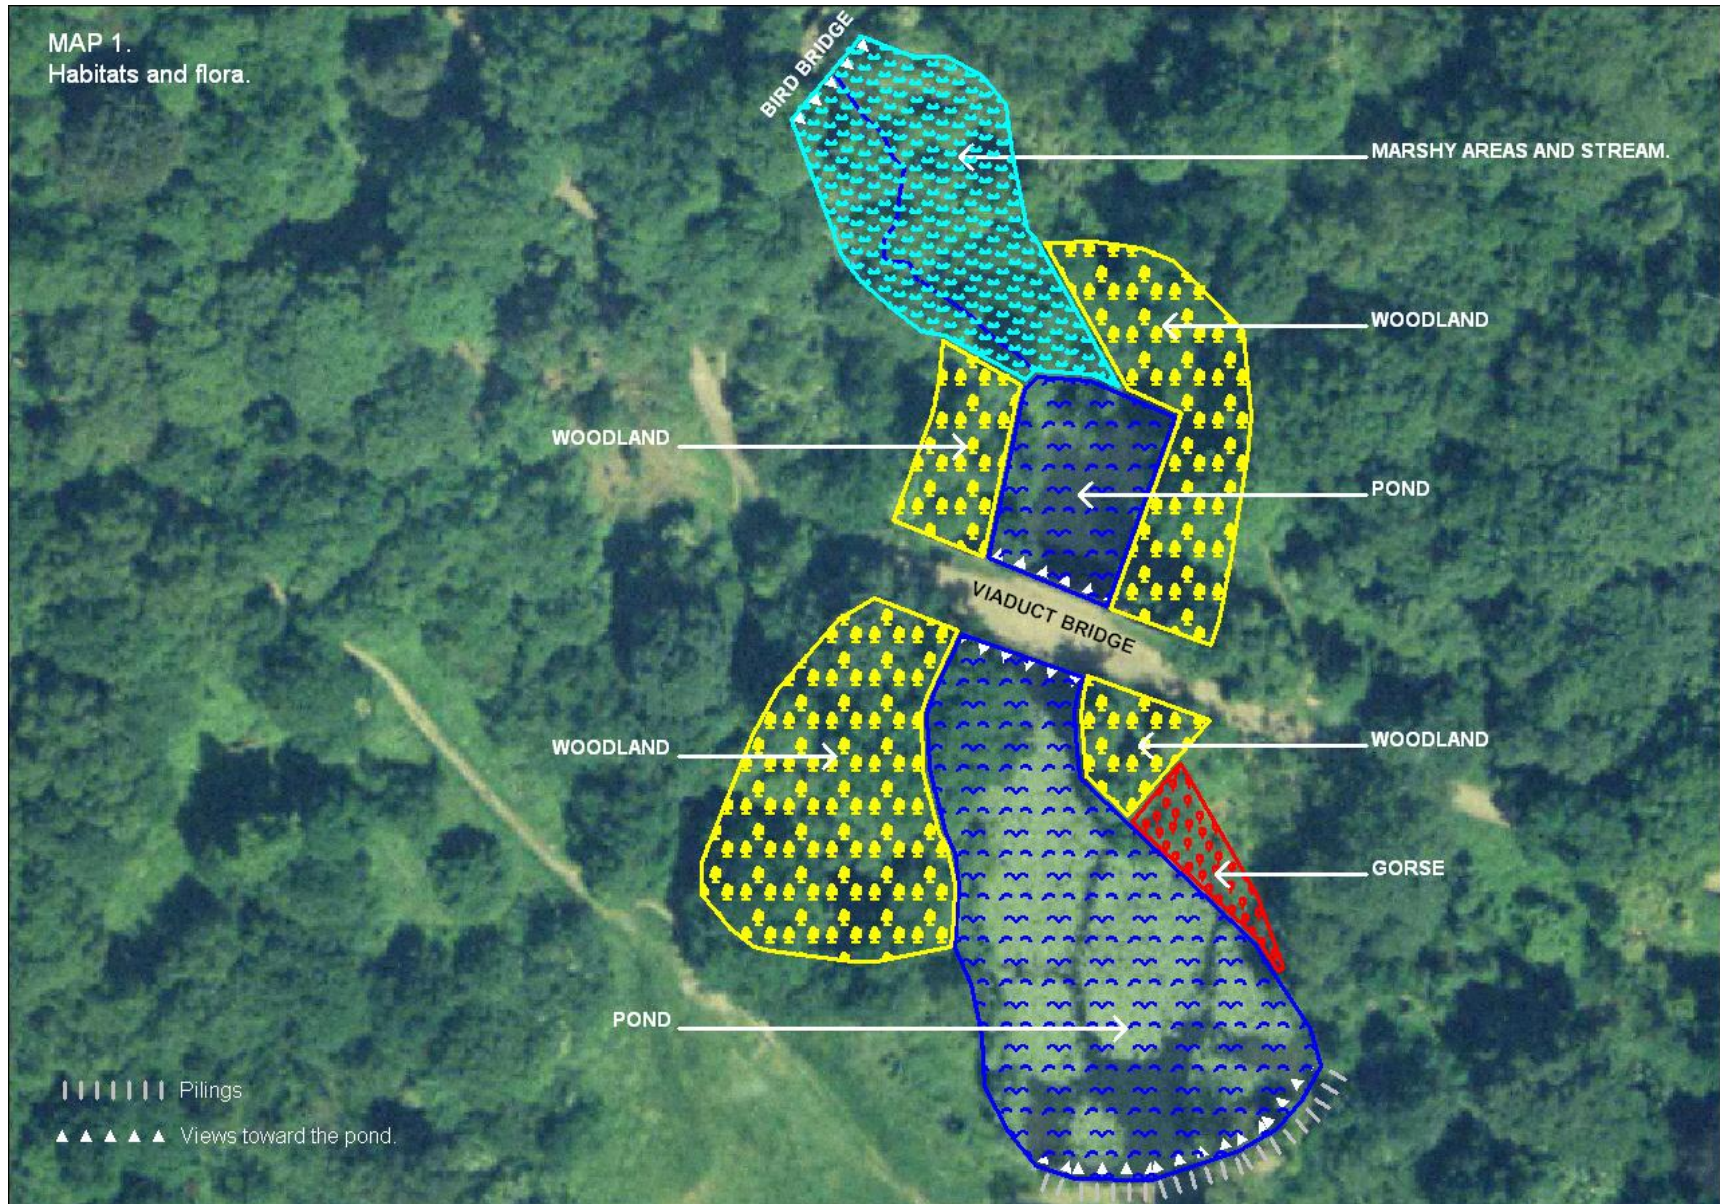
MAP 1.
Habitats and flora.

1.3. Ecology. See Map 1.

The Viaduct Pond and its enclosure are made up of many different habitats over a relatively small area. The pond has been identified as one of the ponds on the Heath to have the highest biodiversity. This is largely because of the great amount of submerged vegetation.

1.1. Location. See map 1 on p2.

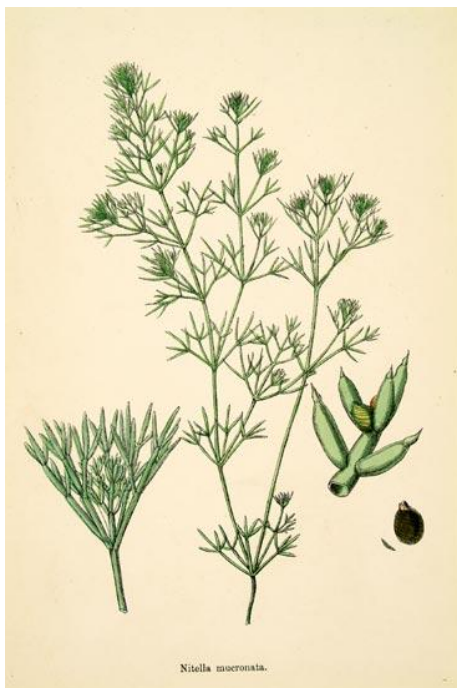
Fig 2.

A survey in 1999 by Dan Hackett identified the presence of pointed stonewort (*Nitella mucronata*) illustrated in figure 2, a species that is nationally scarce.

Nitella mucronata is described by Groves and Bullock-Webster (1920) as “singularly fugitive and seems rarely to occur in the same station in two successive years.” However the population in the Viaduct Pond was first recorded in 1999 by Dan Hackett and found by him in 2001, 2002 and in 2004. It was looked for, and found again, in 2008, when the pond was drained for restoration work. It is plausible that this colony of *Nitella mucronata* has been in the Viaduct Pond constantly since at least 1999. That it has remained there and flourished in spite of competition from macrophytes as aggressive as *Elodea* shows a rare tenacity.

Despite stonewort's low tolerance of eutropic water, this scarce plant still remains in the Pond ten years after it was first identified by Dan Hackett.

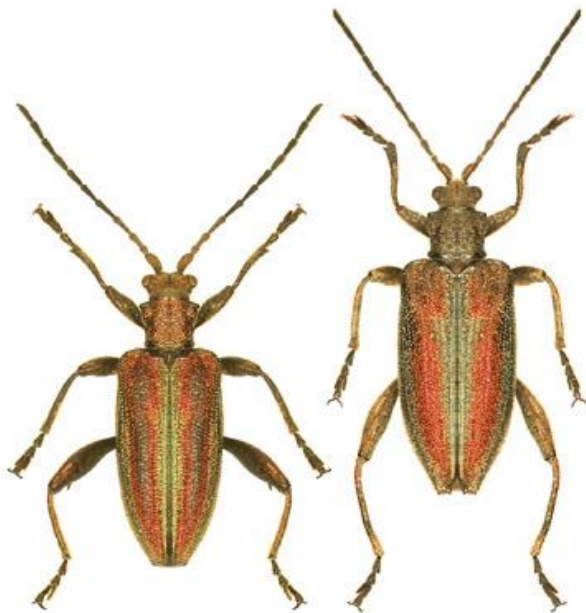
Fig 3. Not to scale.

The Dan Hackett survey identified the presence of reed beetle (see figure 3). Due to its low tolerance of eutropic water a survey should be carried out to confirm whether this rare species still occurs here.

Reed beetles (*Donacia aquatica*) inhabit aquatic vegetation such as sedge in small numbers at the margins of open water. Adults are most active during May and June.

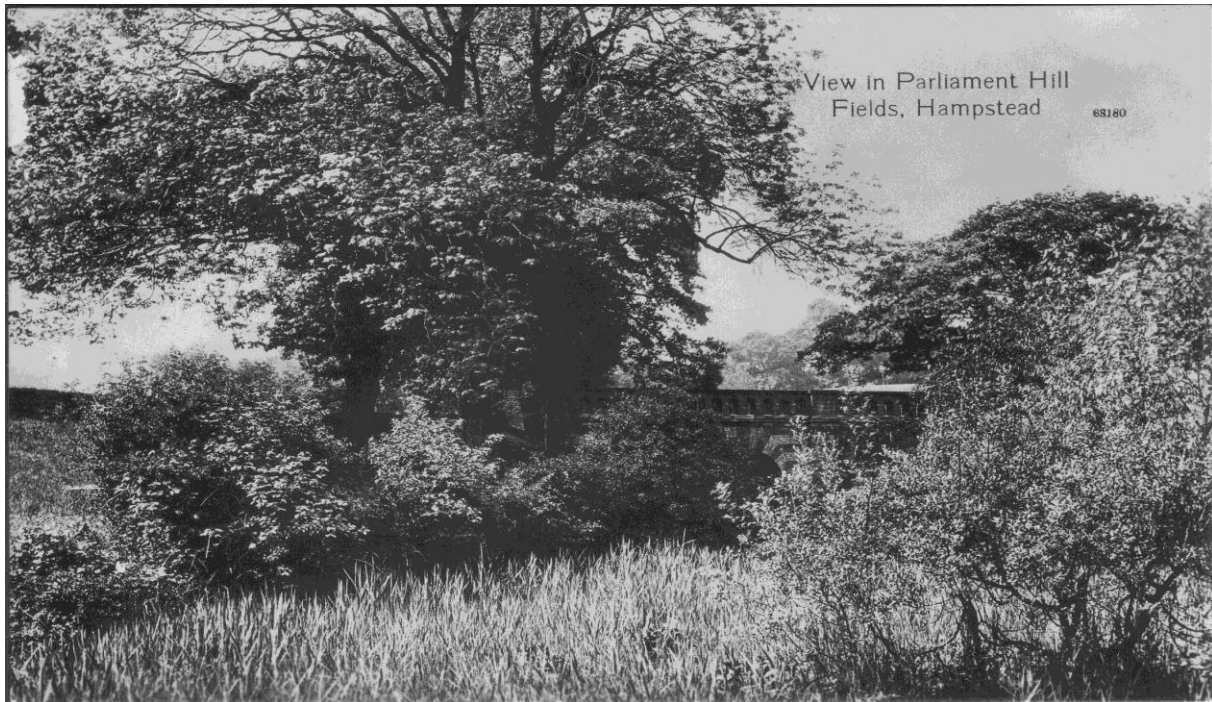
Fig 4.

Glimpses of the Bird Bridge could once be seen from the Viaduct as seen in figure 4. These historic view points tell a small part of the Hampstead Heath story, of how it was saved and how it was intended for development. The Bird Bridge has since become hidden from view by encroaching woodland and its interesting architecture is all but impossible to see clearly.

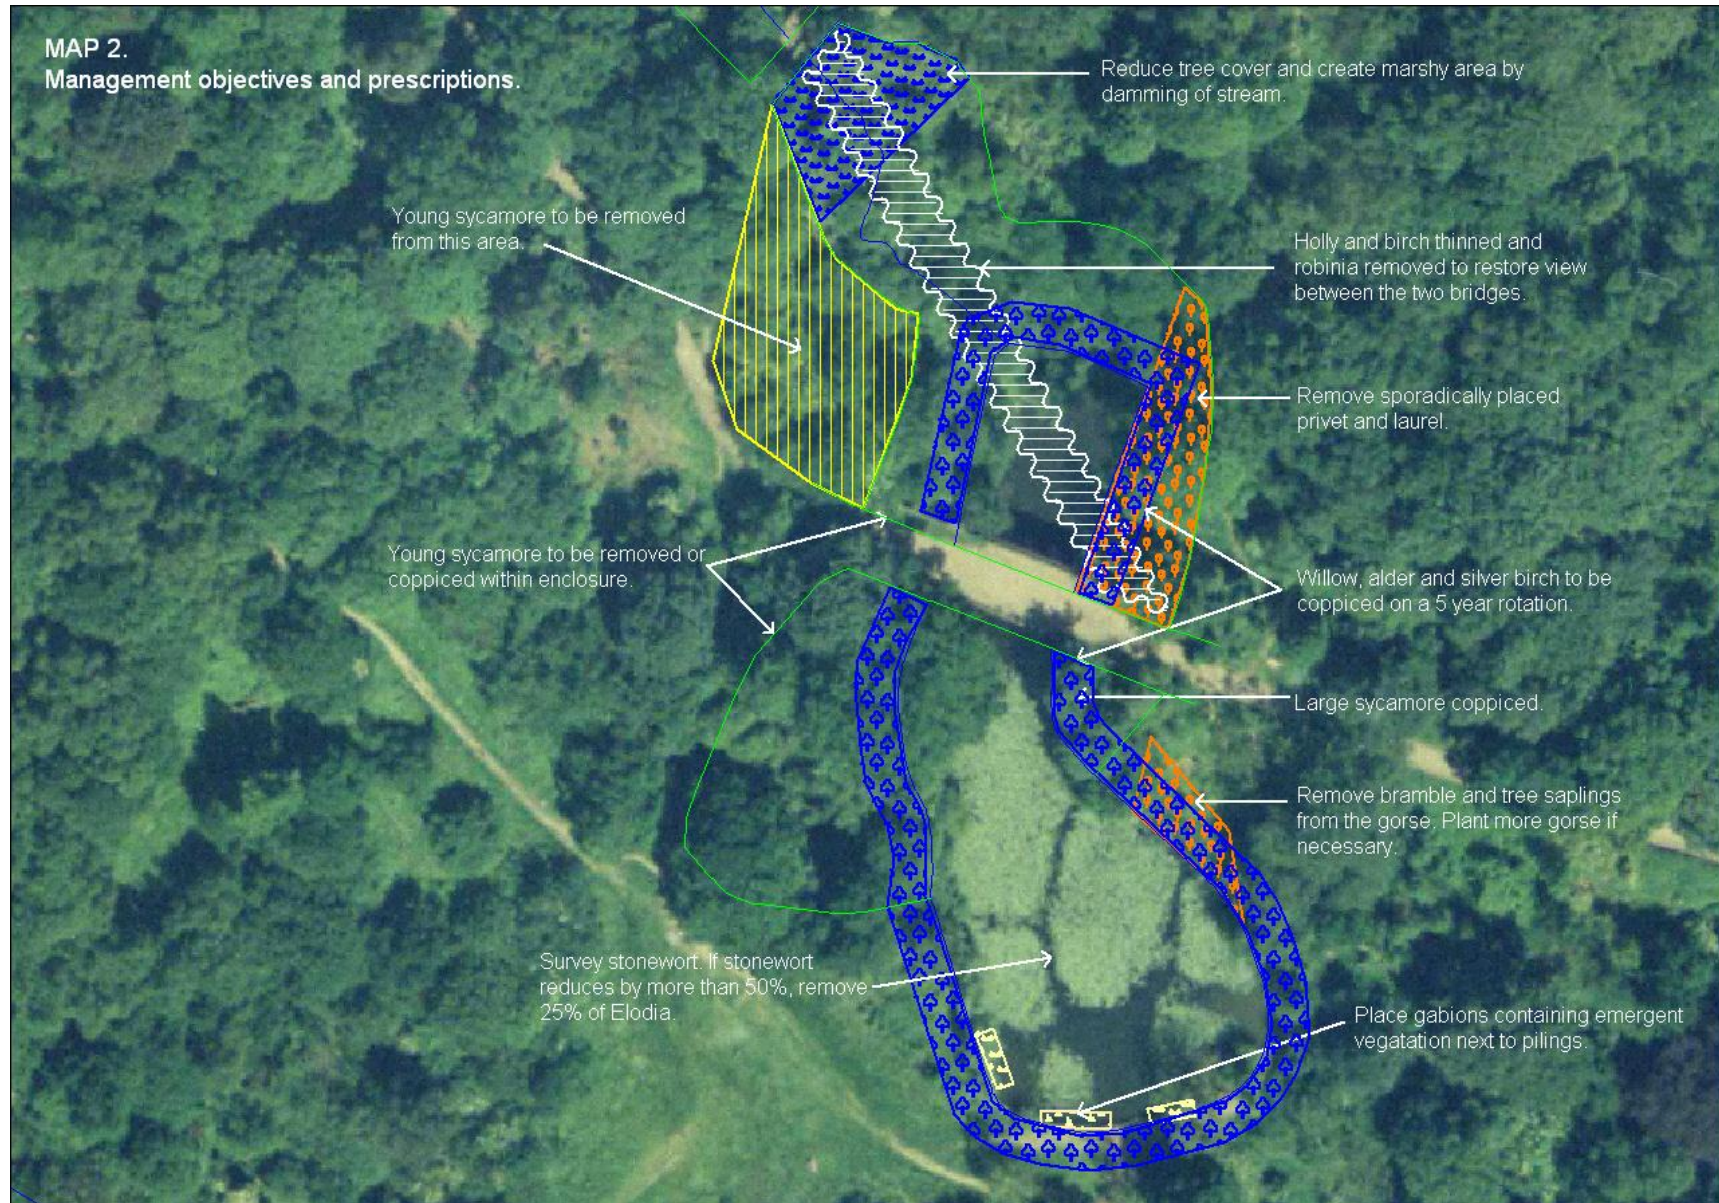
MAP 2.
Management objectives and prescriptions.

3.1. Regular management tasks. See map 2.

Objective	Prescription	Frequency	Month(s)	Years	Who by	Priority
Monitor presence of reed beetle.	Survey around sedge and water lily.	Twice a year	May and June	2010 onwards	P.H.F. con-unit/Ecologist	High
Monitor presence of stonewort.	Survey around Canadian pondweed. See map 2.	Once a year	October	2009 onwards	P.H.F. con-unit/Ecologist	High
Reduce the competition to stonewort if quantity reduced by 50%.	Remove 25% of Canadian pondweed.		October		P.H.F. con-unit	Medium - high
Manage sycamore to reduce shade.	Sycamore saplings (inside the enclosure) removed where possible. Sycamore removed outside the enclosure north west of viaduct.	Every 5 years	October-February	2009 onwards	P.H.F. con-unit	Medium
Control invasive species.	Remove Himalayan balsam.	Every year	June till September	2010 onwards	P.H.F. con-unit	Medium
Maintain coppice to reduce build up of litter deposited into pond.	20% (approx 55m of pond edge) of alder, willow coppiced every year where they occur within 5m of pond edge.	Every year	October-February	2010 onwards	P.H.F. con-unit	Medium
